ENTIAT RIVER INVENTORY AND ANALYSIS

Chelan County Conservation District

JANUARY 6, 1998

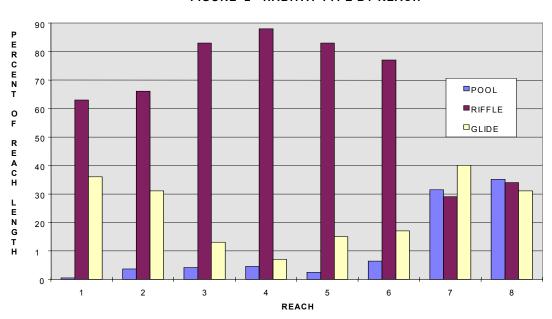
FIGURE 2 - HABITAT TYPE BY REACH

1. *Habitat type* - Less than 1000 feet of cascades were noted for all of the reaches. There were no waterfalls. The length of channel that is composed of pools, riffles and glides is shown for each reach in **Figure 2**. Note that glides are fairly common throughout the survey length, but dominant only in Reach 7. Riffles are, by far, the dominant habitat type in the first six reaches. This, combined with the lack of large pools and complexity of cover (see **Figure 3**), is typical in channelized streams.

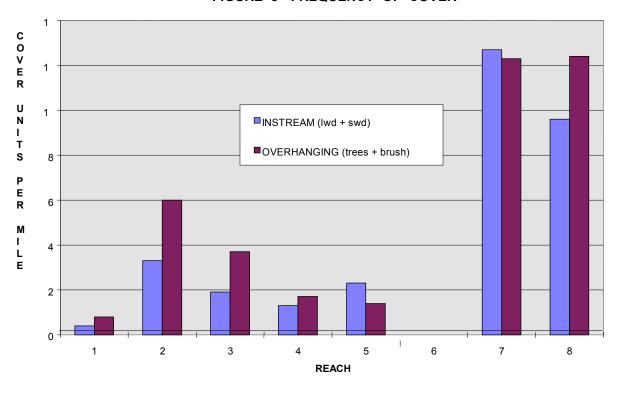
FIGURE 3 - FREQUENCY OF COVER

The amount of cover that relates to *stream shading* is termed "percent canopy" (**Table 1**). Since this type of cover refers to the canopy of trees, it is relatively high above the channel. Cover, as it relates to *fish habitat*, can be: (1) <u>instream</u> - anything that breaks up the streamflow by protruding into the water at, or below, bankfull flow - either from the bottom or from the banks of the channel; or (2) <u>overhanging</u> - usually live vegetation that protrudes from the top or side of a bank, and over (and very close to) the low-water surface of the channel. All three forms of cover have been removed from Reach 6 due to the 1994 fire which burned most of the wood in the riparian corridor.

No overhanging trees were counted in the first six reaches. **Figure 3** shows that the first appearance of overhanging tree cover occurs in Reaches 7 and 8. The tree species that provides much of the observed overhanging cover in the upper reaches is water birch. Limited cover is also created by some willow species, alders and small cottonwoods.
