TECHNICAL MEMORANDUM

TO: Kurt Hosman – Cascadia Conservation District **DATE:** September 28, 2007
FR: Jay Pietraszek - Golder **OUR REF:** 053-1000.300
Bob Anderson – Golder
RE: Status report of the floodplain storage project at Cottonwood Flats

This memorandum is a project status report for the WRIA 46 Step B Storage Assessment. The Step B Assessment focuses on a floodplain storage project that was implemented on the Entiat River, near the Town of Ardenvoir. The project began in February 2007. To this point the project has consisted of a background study of hydrologic and hydrogeologic conditions on the floodplain. Section 2 of this report details the installation of piezometers that are used to measure groundwater levels. Section 3 details the water level data collected from the piezometers. An estimate of the storage capacity of the floodplain site is provided in Section 4.

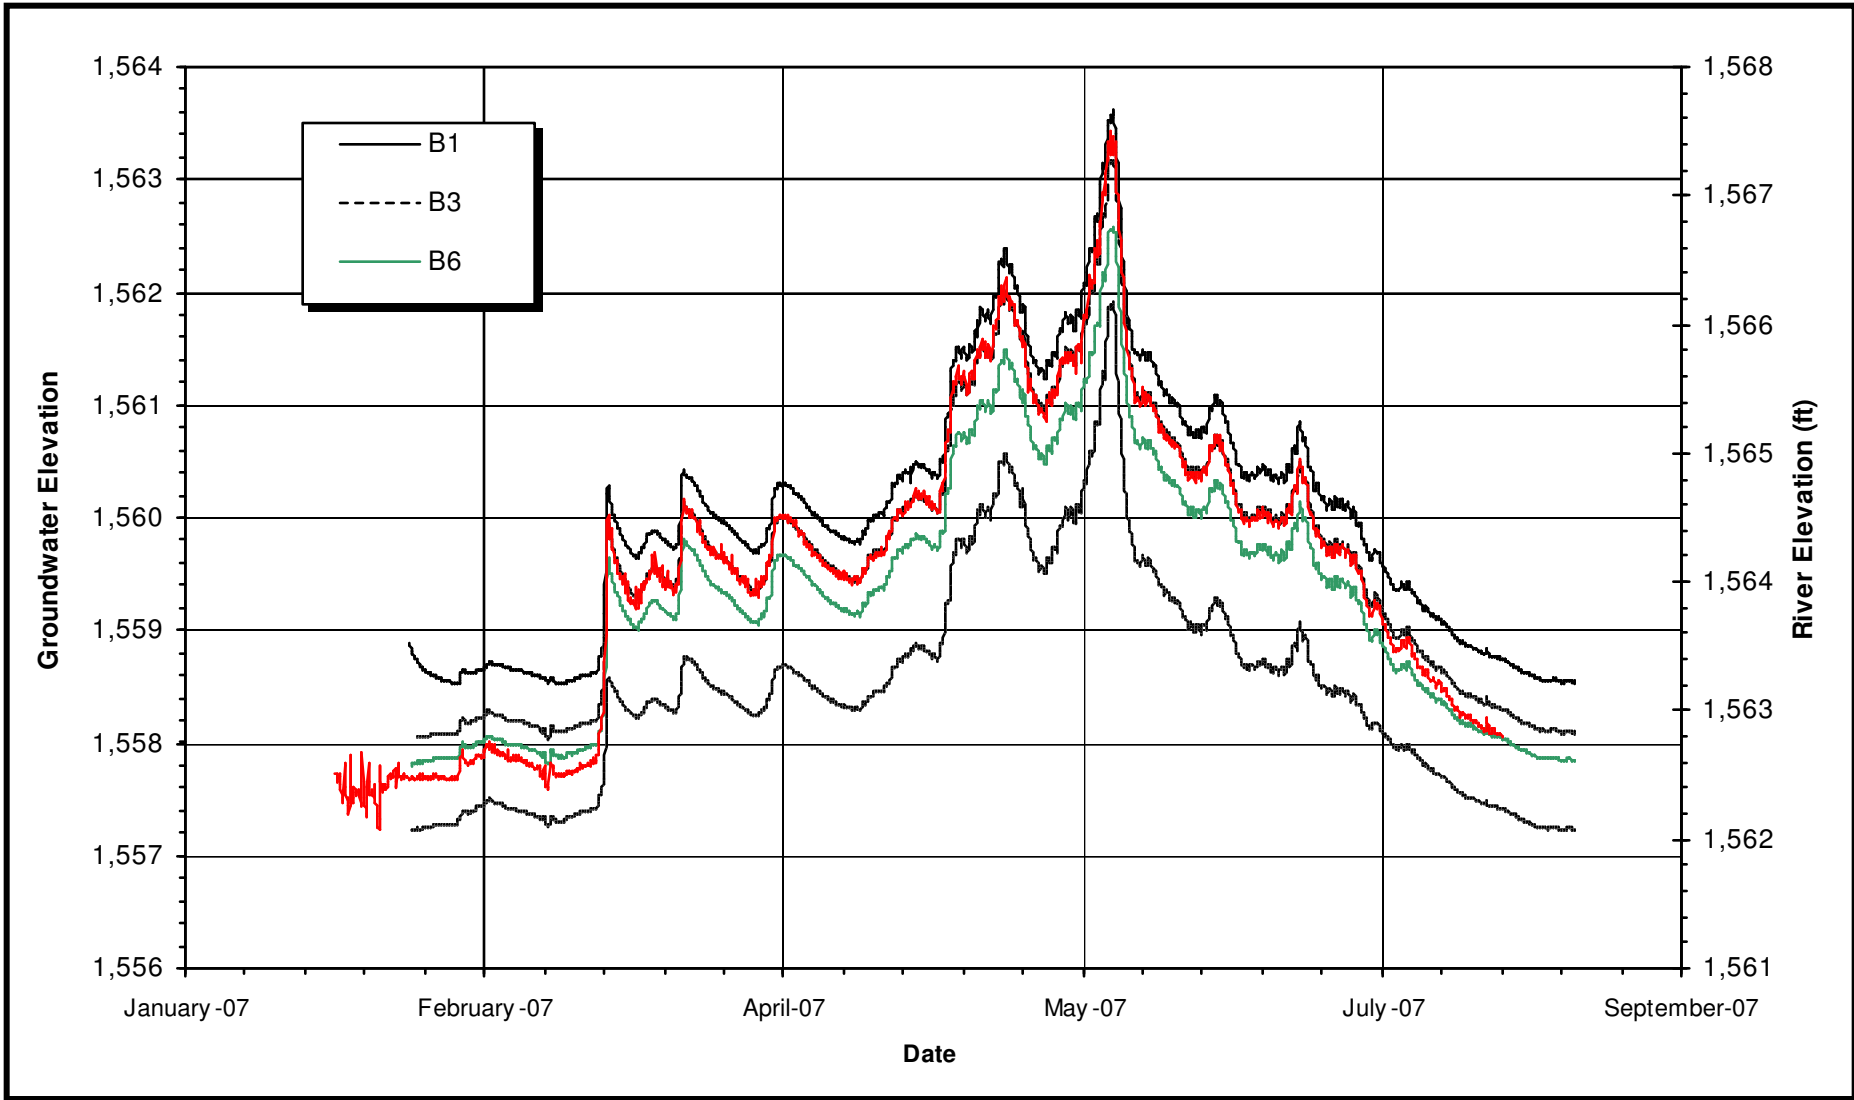
Chelan County Conservation District Step B Storage Assessment	TITLE Hydrographs for the Entiat River at Ardenvoir and Piezometers B1, B3, B6, and B9		
	DRAWN JP CHECKED RA REVIEWED RA	DATE Sep-07 SCALE na FILENAME hydrogrpah figures.xls	JOBNO. 053-1000.300 DWG.NO. na FIGURENO. 3-1

Figure 3-1 compares the hydrograph from the USGS Entiat River streamflow gage to the hydrographs from the four piezometers (B1, B3, B6, and B9) that are situated closest to the Entiat River on the project site. The USGS streamflow gage (Entiat River at Ardenvoir) is located about 1/3 mile upstream of the project site. The purpose of Figure 3-1 is to show that the water level fluctuations at these four piezometers mirror the water level fluctuations in the river.

Figures 3-1 to 3-4 show groundwater elevations at the nine piezometers between February 7th and August 21st, 2007. Water levels were at their lowest from February to early March. On March 10th water levels rose quickly then remained relatively stable until the snowmelt runoff began around May 7th. Water levels peaked on June 5th, and then receded sharply until about June 10th. A more gentle sloping recession was observed beginning about June 10th and August 21, 2007.

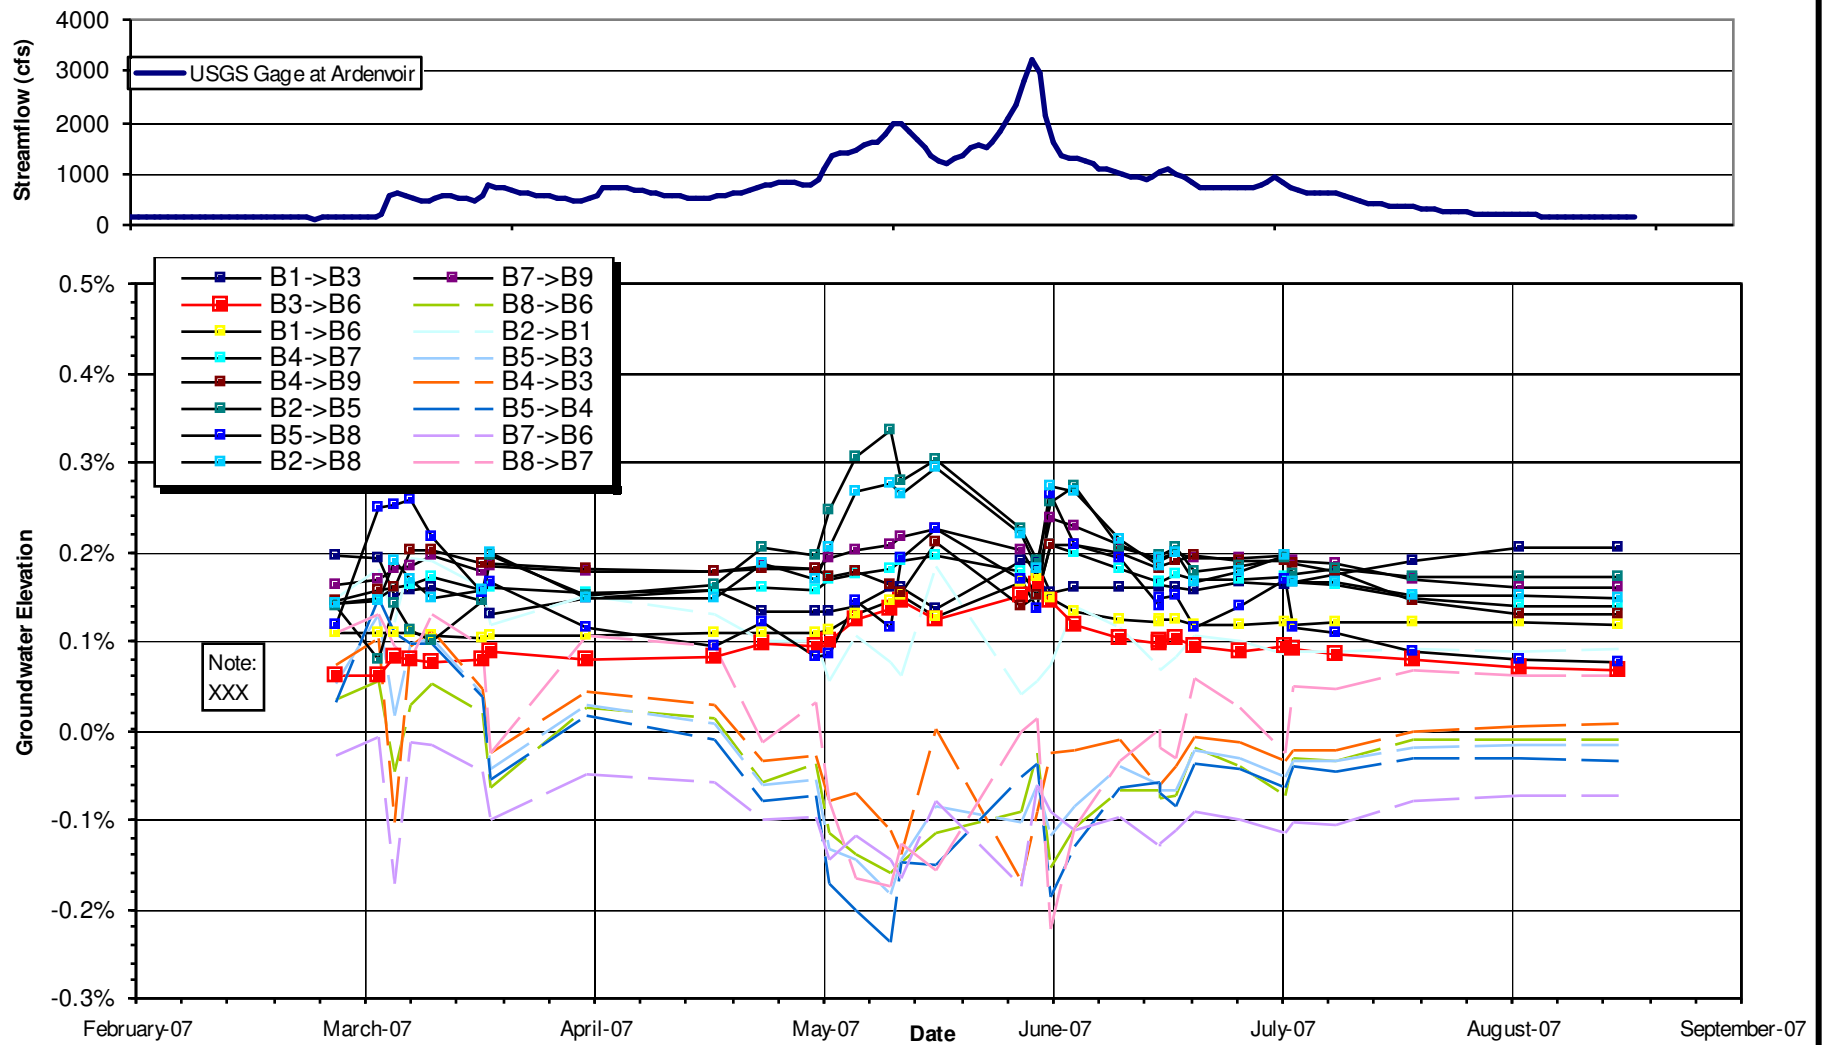
Chelan County Conservation District Step B Storage Assessment	TITLE Groundwater Gradients		
	DRAWN JP	DATE Sep-07	JOBNO. 053-1000.300
	CHECKED RA	SCALE na	DWG.NO. na
	REVIEWED RA	FILENAME Gradient figures.xls	FIGURENO. 3-5

Gradients were calculated between piezometers in two directions: (1) across the floodplain (perpendicular to the river), and (2) down the floodplain (parallel to the river). Figure 3-5 shows the gradients between various piezometers at selected times during the study period. In general, the gradients parallel to the river (or downstream) are higher than the gradients perpendicular to the river (or cross-stream). In other words, the strongest direction of groundwater flow follows the direction of the river.

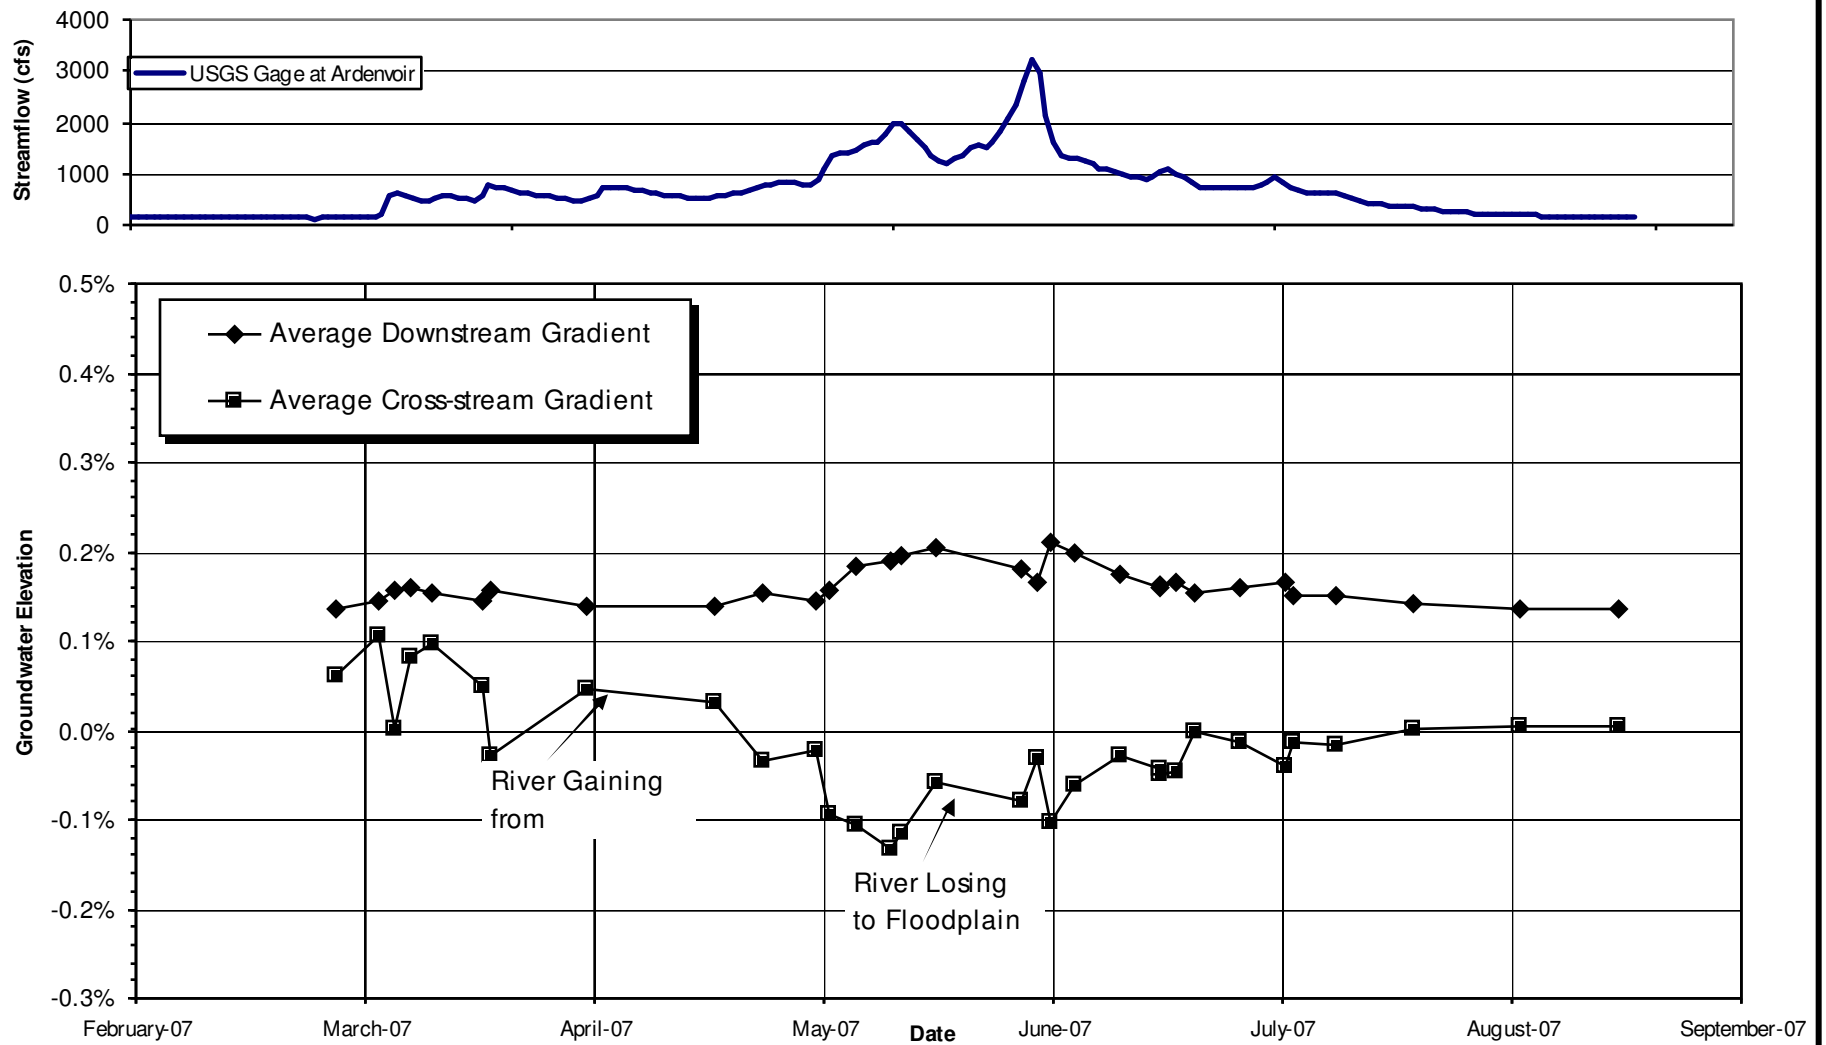
Chelan County Conservation District Step B Storage Assessment				TITLE Average Cross-stream and Downstream Groundwater Gradients			
				DRAWN JP	DATE Sep-07	JOBNO. 053-1000.300	
CHECKED RA	SCALE na	DWG.NO. na					
REVIEWED RA	FILENAME Gradient figures.xls	FIGURENO. 3-6

Figure 3-6 shows the average downstream gradient and the average cross-stream gradient over the study period. A positive gradient indicates that groundwater is moving from the floodplain to the river (a river-gaining condition). A negative gradient indicates that groundwater is moving from the river to the floodplain (a river-losing condition). The average cross-stream gradient is positive (gaining) from March to late April, negative (losing) from late April through late July, and neutral during August and September.

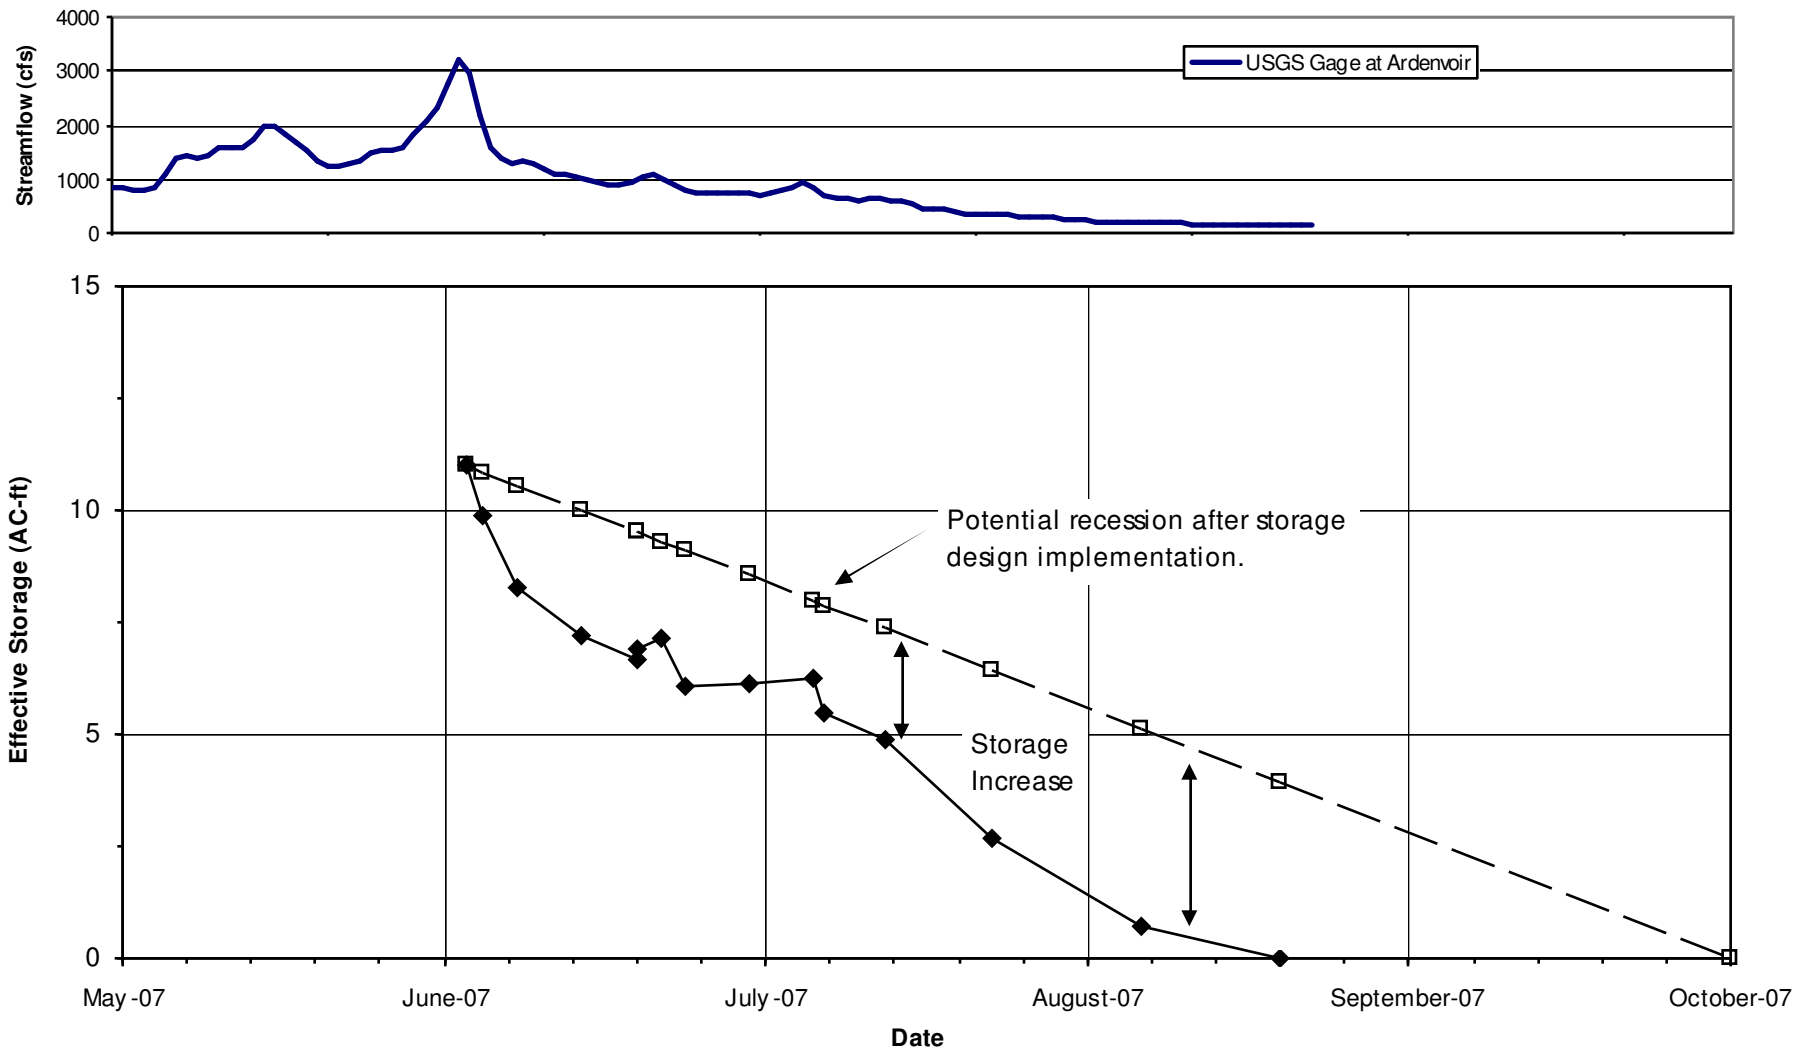
Potential Storage Benefit

Figure 4-2 shows the current seasonal decline in storage volumes on the floodplain compared to a hypothetical “post-storage” condition. In the hypothetical condition, the seasonal decline in storage volumes is reduced by 50%, to approximately 2.5 AF per month. By slowing the rate of decline, groundwater discharge back to the river is reduced, but the total duration is lengthened and discharge to the river in the late summer is increased.

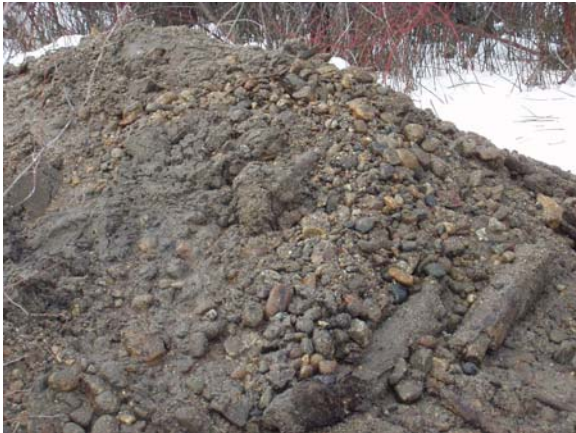
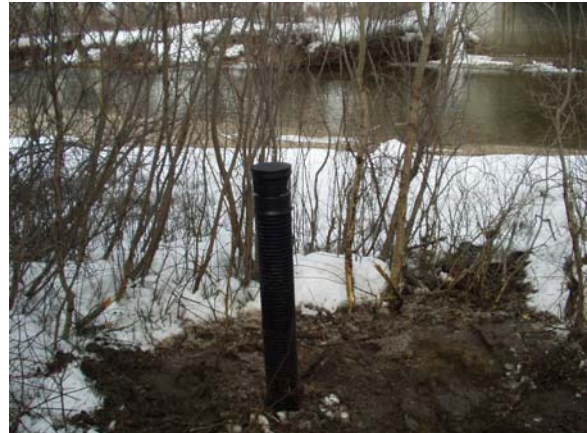
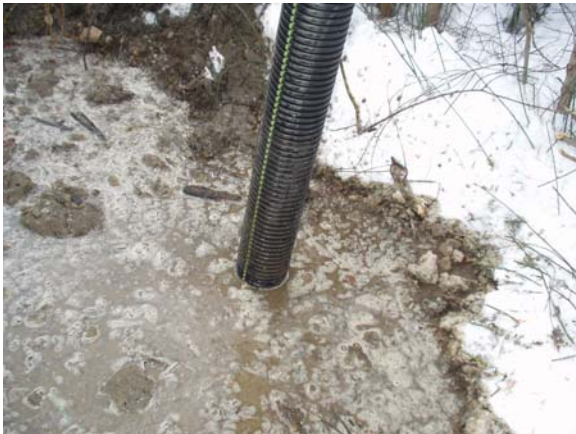
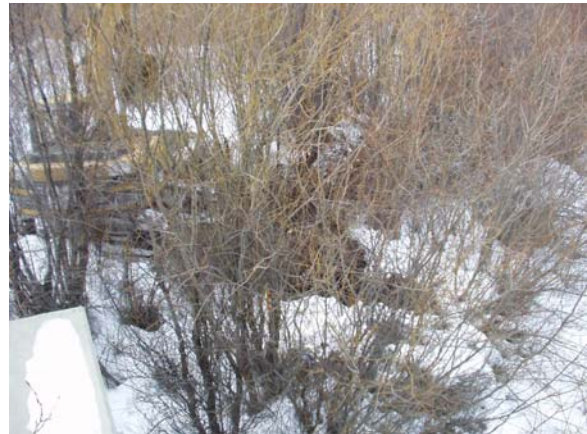
Test Pit: B1 Location: Entiat Floodplain Date Installed: 5 Feb 07 15:31
 Engineer: Pietraszek Contractor: Batchelor Excavation

Depth (ft bgs)	Description	Samples	
		No	Depth
0-2.5	Brown (f-m) SAND, sm silt, sm organic material, lt-sm cobbles, lt-tr clay. (Topsoil)	1	5
2.5-6	Brown speckled (c) GRAVEL and COBBLES, lt-sm (c) sand, lt wood. (Coarse Alluvium)	2	10
6-10	Same as above but with sm (m-c) sand and lt-sm silt (Alluvium)

Special Notes: Hit water at 2.5 feet. Very coarse material intersected at 2.5 feet. Material became slightly finer at about 6 feet.

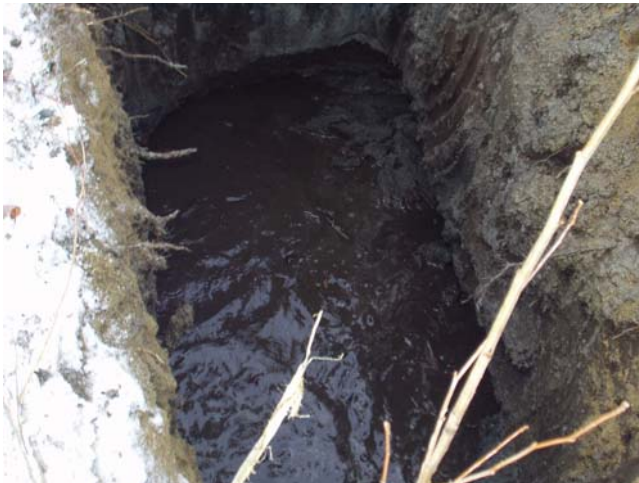
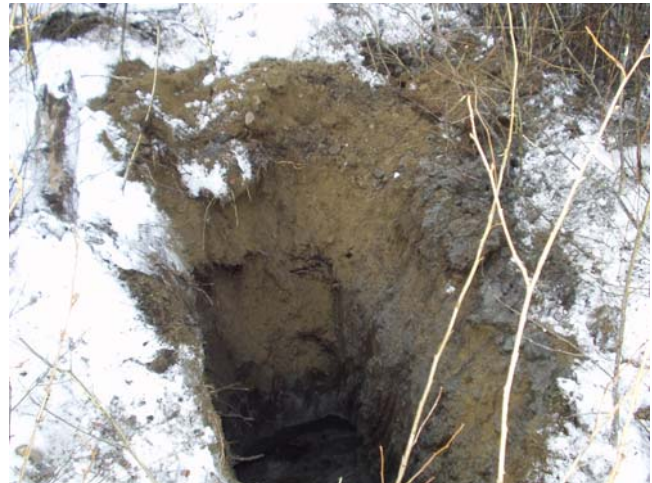
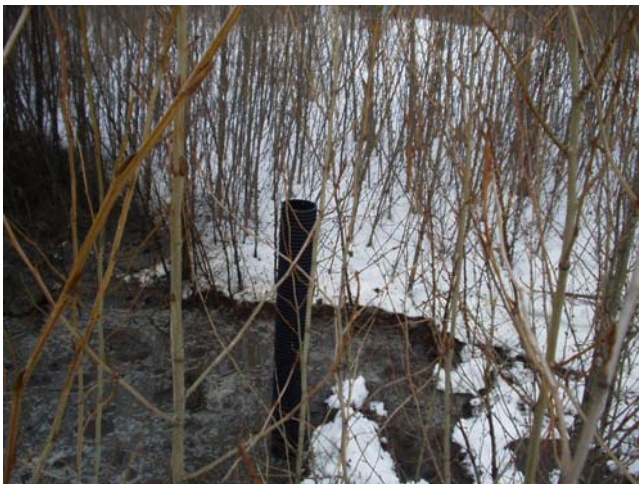
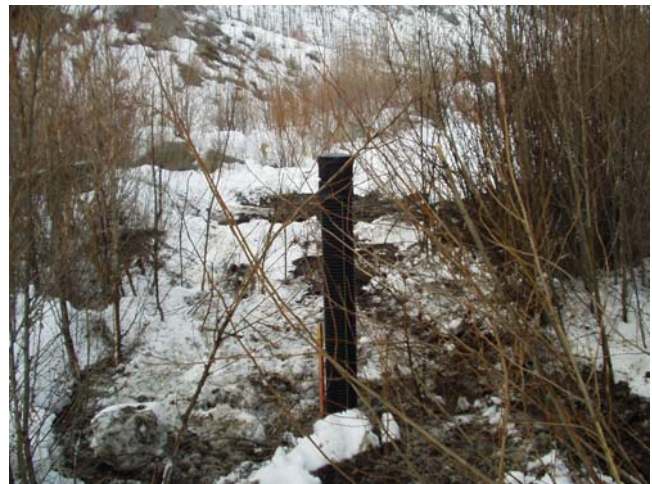
Test Pit: B2 Location: Entiat Floodplain Date Installed: 5 Feb 07 14:30
 Engineer: Pietraszek Contractor: Batchelor Excavation

Depth (ft bgs)	Description
0-2	Brown (f-m) SILT, sm sand, sm organic material, lt-sm gravel. (Topsoil)
2-5	Brownish-black (f-c) Sand and GRAVEL, sm silt, loose (Medium Alluvium)
5-10	Gray (f-c) SAND and GRAVEL, sm cobbles, tr wood (m-c Alluvium)

Special Notes:
 Hole began caving at about 6 feet bgs
 Water at 5 feet bgs

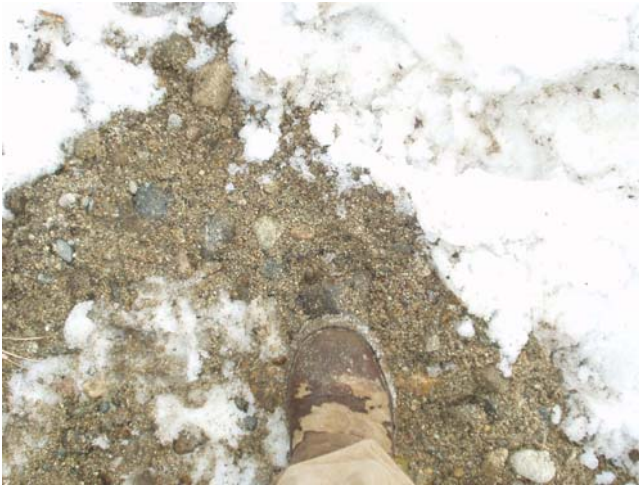
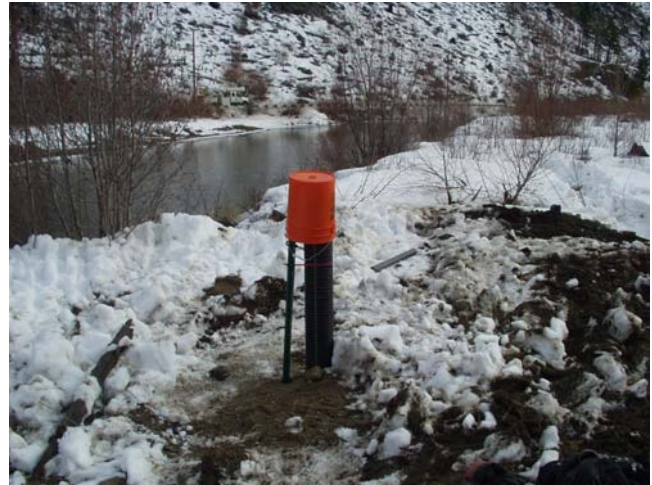
Test Pit: B3 Location: Entiat Floodplain Date Installed: 6 Feb 07 15:20
 Engineer: Pietraszek Contractor: Batchelor Excavation

Depth (ft bgs)	Description
0-0.5	Brown (f-m) Topsoil
0.5-1	Light brown (c) SAND and (f-c) GRAVEL, sm cobbles, loose, dry, weakly stratified (Coarse Alluvium)
1-2	(m-c) SAND, sm gravel
2-9	SAME AS 0.5-1 (Coarse Alluvium)

Special Notes: Water encountered 6.5 feet bgs

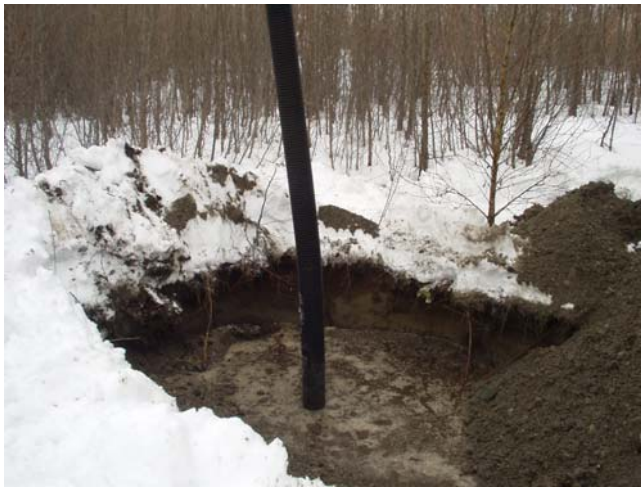
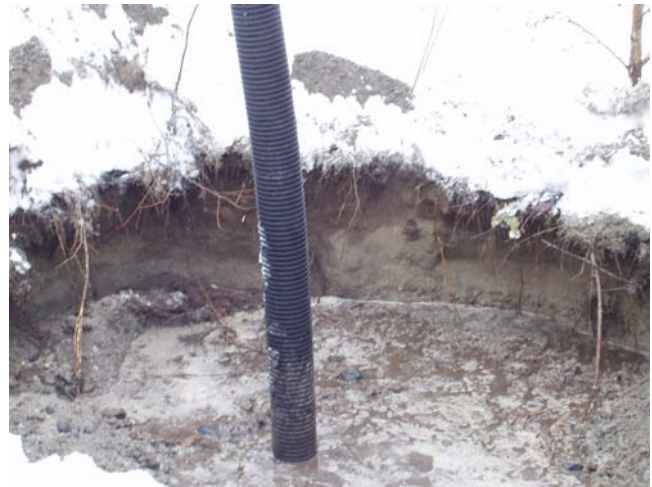
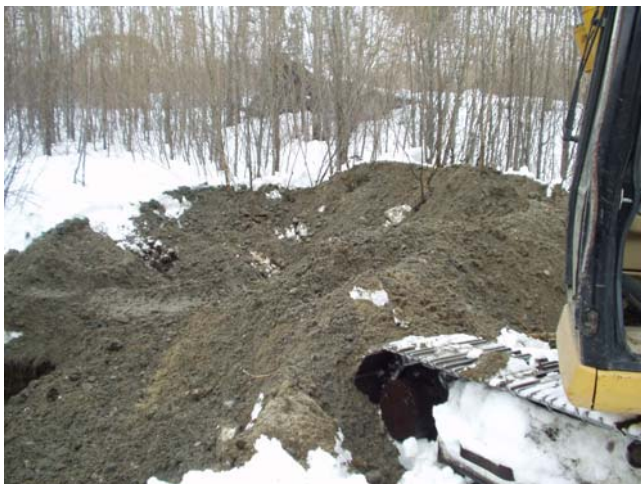
Test Pit: B4 Location: Entiat Floodplain Date Installed: 6 Feb 07 13:13
 Engineer: Pietraszek Contractor: Batchelor Excavation

Depth (ft bgs)	Description
0-1.5	Medium brown (f-c) SILT and (f) SAND, sm organic material, little stiff (Topsoil)
1.5-7	Brown (m-c) SAND, lt-sm (f-c) gravel, lt-tr cobbles, weakly stratified
7-9	Grayish-brown (c) SAND and (f-c) GRAVEL, sm cobbles (Coarse Alluvium)

Special Notes: Hit water at 6-7 feet bgs

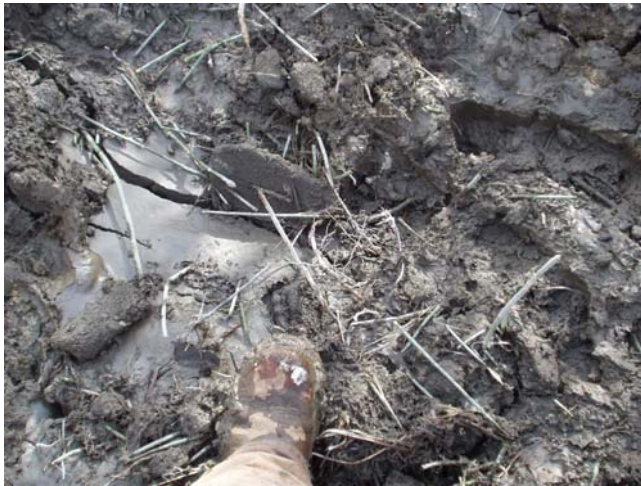
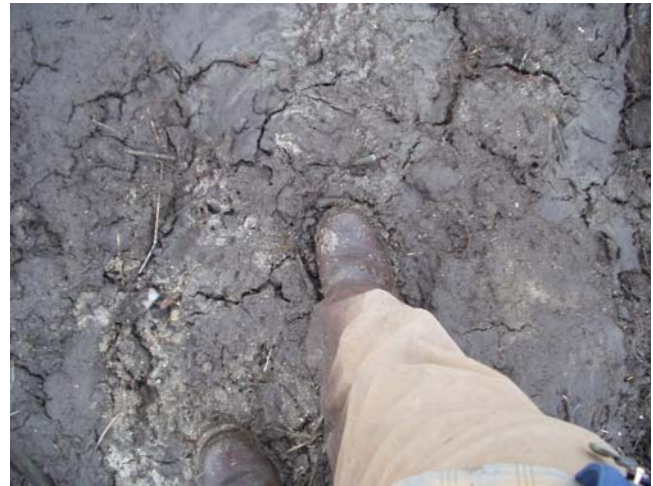
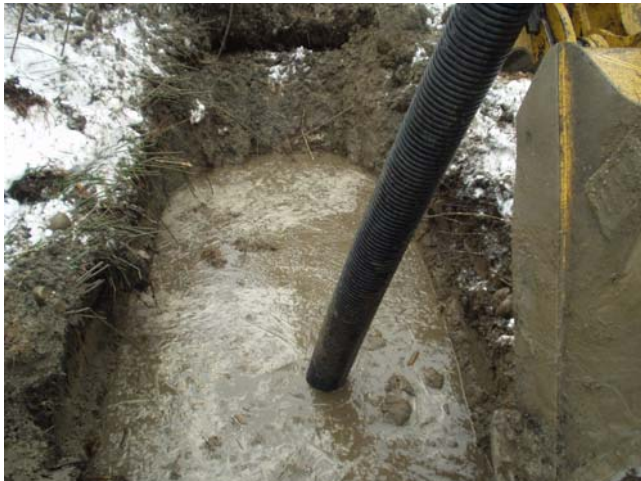
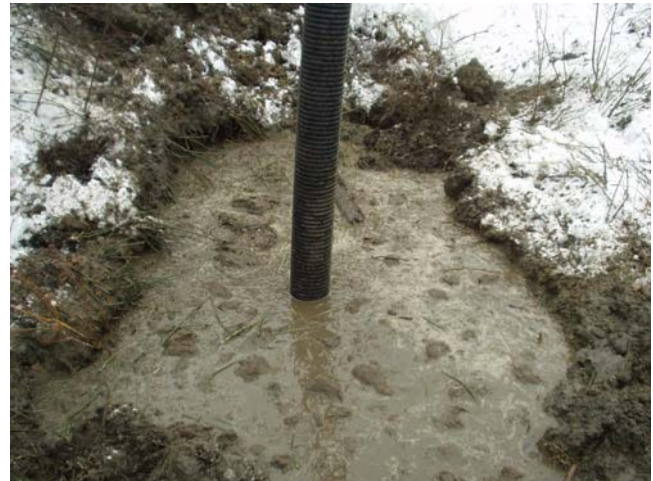
Test Pit: B5 Location: Entiat Floodplain Date Installed: 6 Feb 07 14:30
 Engineer: Pietraszek Contractor: Batchelor Excavation

Depth (ft bgs)	Description
0-1	Dark brown (f-c) SILT sm organic material, moderately stiff (Topsoil)
1-3	Medium brown (f-c) SILT lt (f) sand, moderately stiff
3-7	Gray (f) SAND, sm silt
7-9	Grayish-brown (c) SAND and (f-c) GRAVEL, sm cobbles (Coarse Alluvium)

Special Notes: Hit water at 7 feet bgs

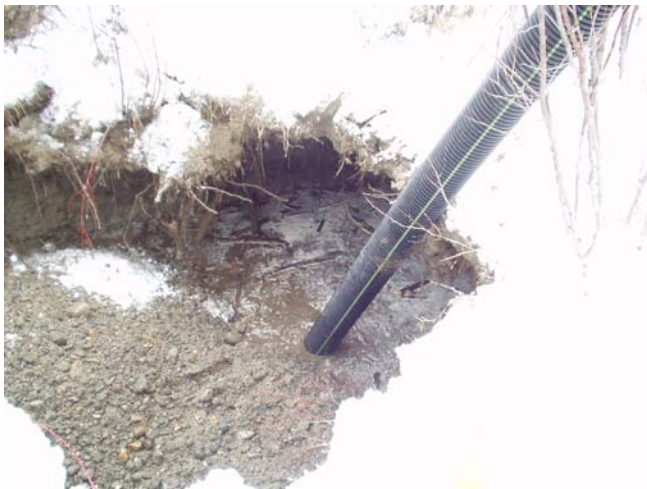
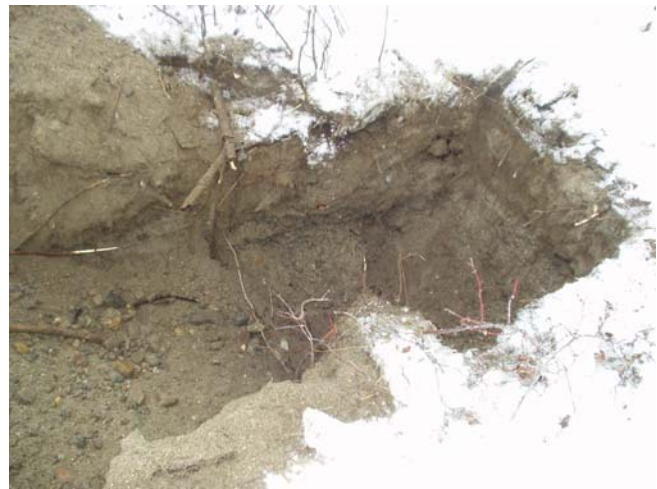
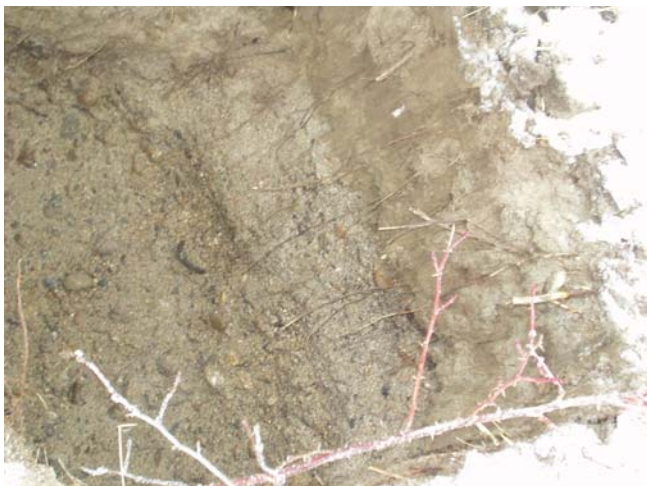
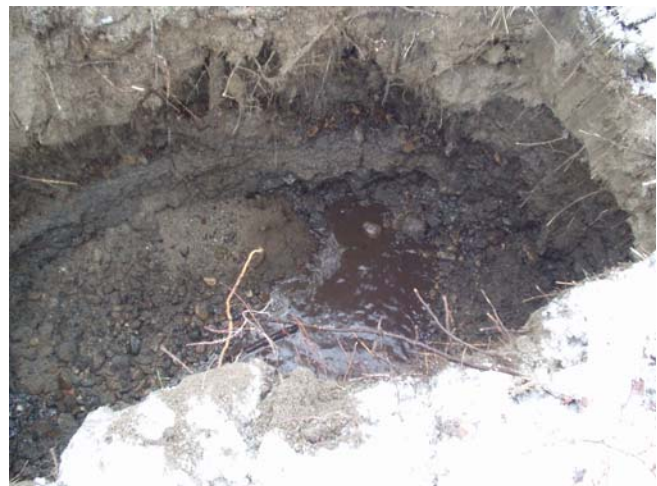
Test Pit: B6 Location: Entiat Floodplain Date Installed: 6 Feb 07 08:30
 Engineer: Pietraszek Contractor: Batchelor Excavation Project: 053-1000.300

Depth (ft bgs)	Description
0-2	Dark (m-c) SAND (top-soil), lt-sm (f-c) gravel and cobbles, sm organic material, loose
2-4	Brown SAND and GRAVEL, sm cobbles
4-7	Brown (c) SAND and (c) GRAVEL, cm cobbles (coarse alluvium) slightly coarser than above
7-8.5	(m-c) GRAVEL and COBBLES, sm SAND, wet (coarse alluvium)

Special Notes:
 Hit water at about 5 feet bgs.
 Material appears weakly stratified below 5 feet bgs. All material is loose. Hole begins caving below 6 feet.

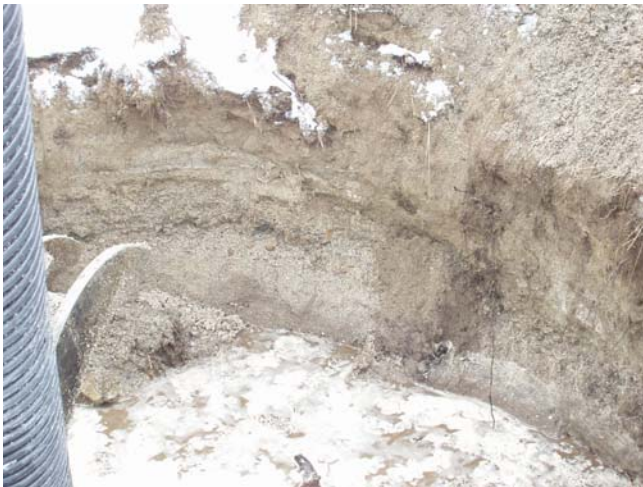
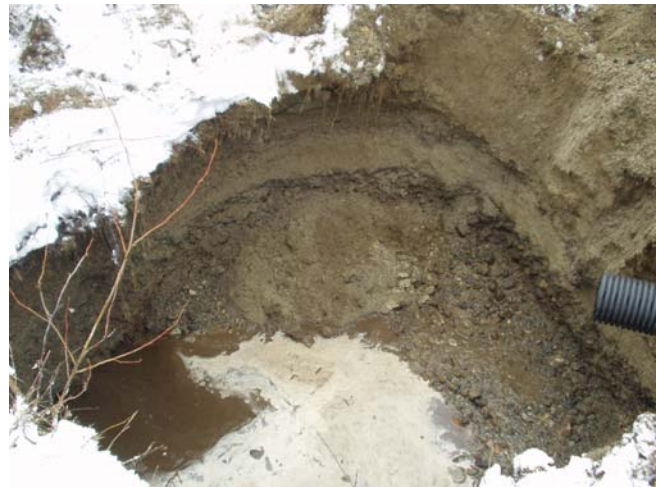
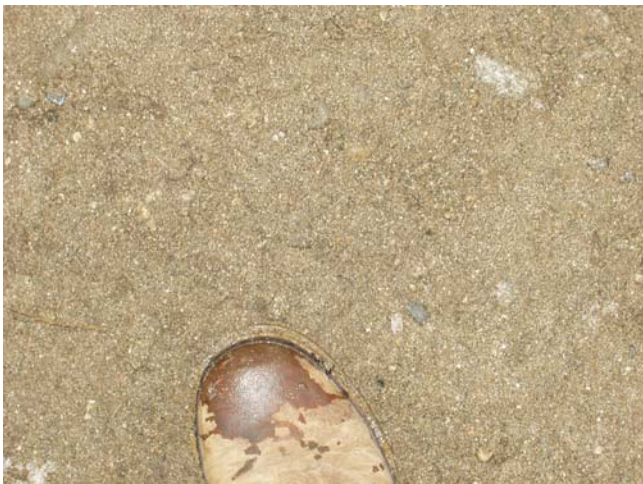
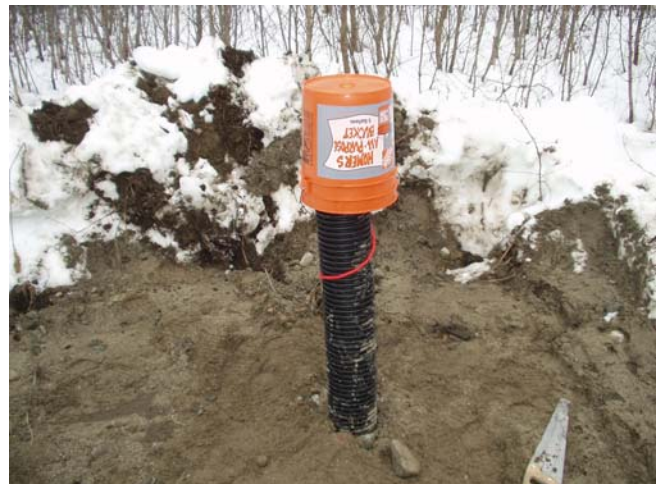
Test Pit: B7 Location: Entiat Floodplain Date Installed: 6 Feb 07 10:30
 Engineer: Pietraszek Contractor: Batchelor Excavation Project: 053-1000.300

Depth (ft bgs)	Description
0-1	Brown (f-m) SAND, sm organic material, loose (topsoil)
1-2	Brown (m-c) SAND and (f-c) GRAVEL, sm cobbles
2-3.5	Brown (m-c) SAND, sm (f-c) gravel (slightly finer than above)
3.5-8.5	Brown (m-c) SAND and (f-c) GRAVEL, sm cobbles (loose, clean) (coarse alluvium)

Special Notes: Water at 5 feet. Weakly stratified below 3 feet.

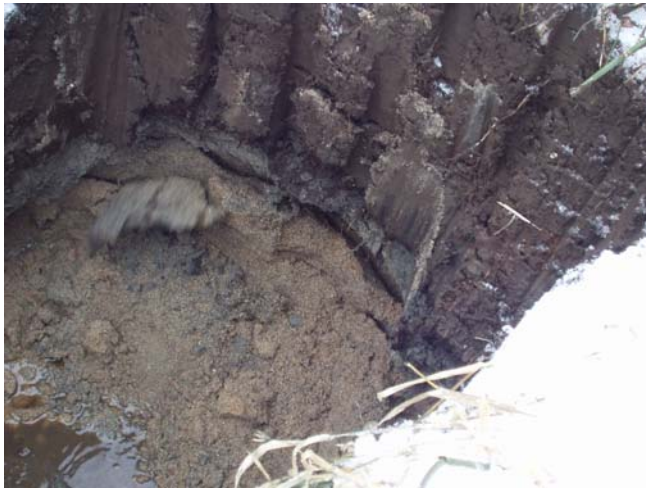
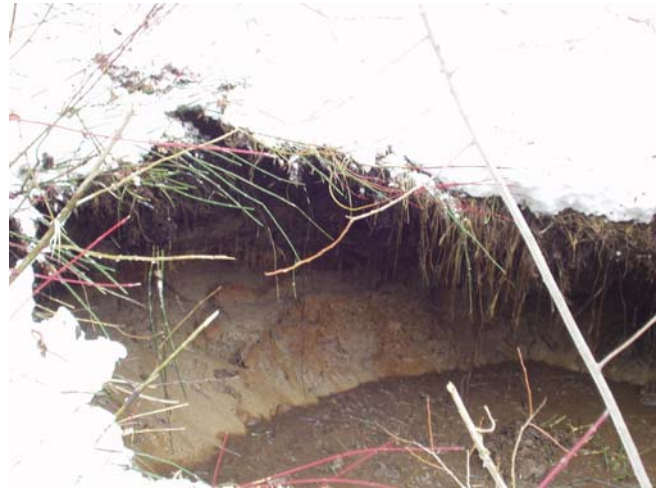
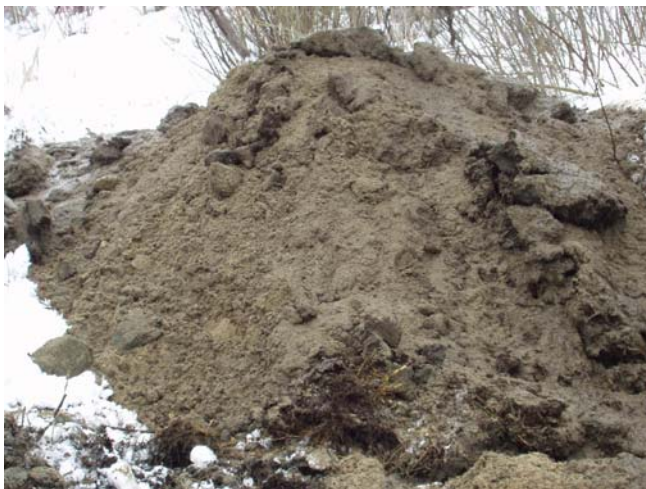
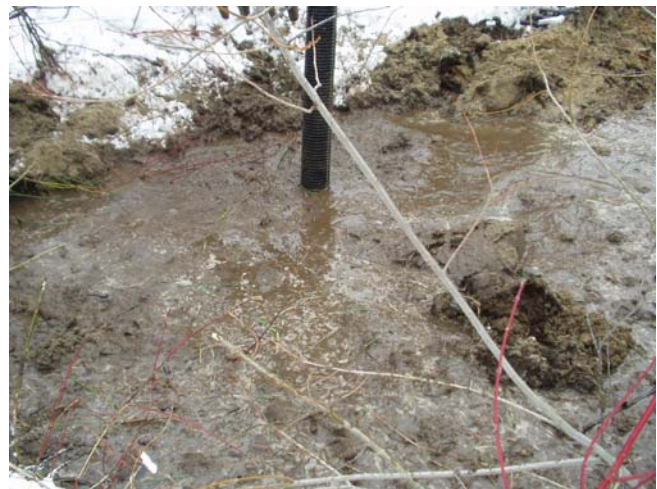
Test Pit: B8 Location: Entiat Floodplain Date Installed: 6 Feb 07 11:30
 Engineer: Pietraszek Contractor: Batchelor Excavation Project: 053-1000.300

Depth (ft bgs)	Description
0-3	Dark Brown SILT, sm organic material, sm (f) sand (little plastic, firm) (topsoil)
3-3.5	Gray (m-c) sand, loose
3.5-7.5	Brown (m-c) SAND, sm (f-c) gravel, little cobbles (alluvium)

Special Notes: Hit water at 5 feet. Hole collapsed below 7.5 feet. Could not excavate below 7.5 feet.

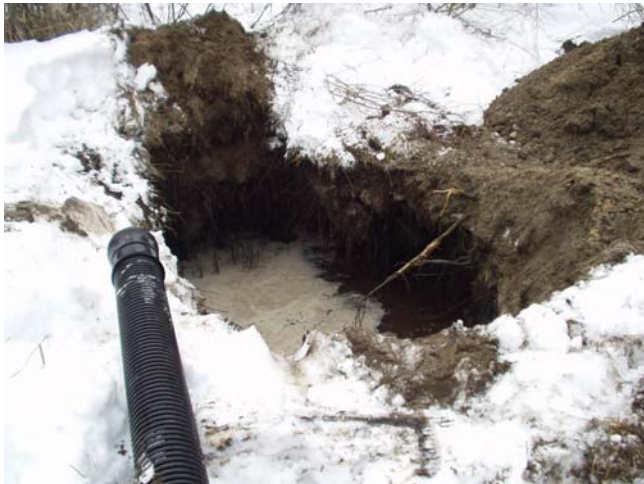
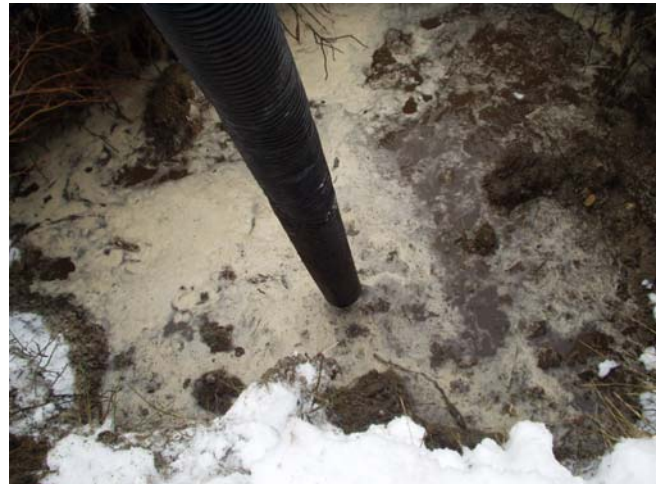
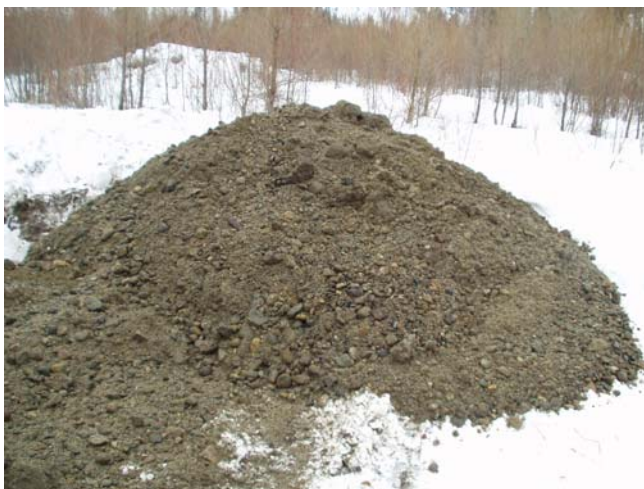
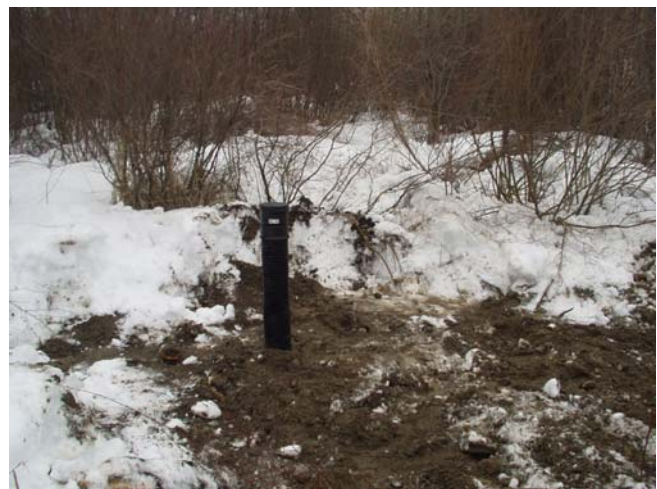
Test Pit: B9 Location: Entiat Floodplain Date Installed: 6 Feb 07 9:45
 Engineer: Pietraszek Contractor: Batchelor Excavation Project: 053-1000.300

Depth (ft bgs)	Description
0-1	Brown (f-m) SAND (topsoil)
1-4	Light Brown (m-c) SAND, sm (f-c) gravel, tr silt (loose) (alluvium)
4-8.5	Brown (c) SAND and (f-c) GRAVEL, sm cobbles, loose (coarse alluvium)

Special Notes: Hit water at 4.5 feet. Hole collapsed at 8.5 feet.
